# **Stonework Heritage in Micronesia**

November 14-15, 2007  
Guam Hilton Hotel, Tumon Guam

## Index of Presentations

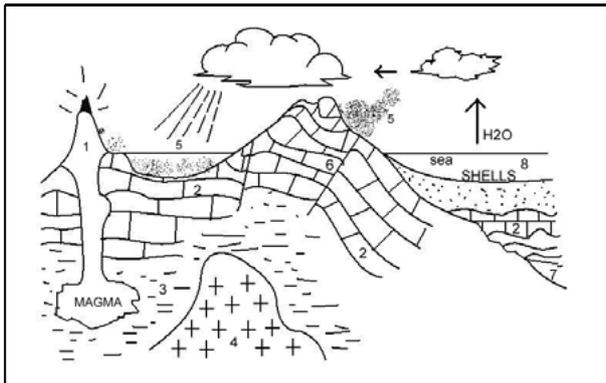
Fig. 4: Genetic Scheme of Rocks (Lazzarini)

- 1. Igneous Rocks: lavas
- 2. Recent Sedimentary Rocks
- 3. Contact Metamorphosed Rocks
- 4. Igneous Rocks: Plutonites
- 5. Sediments
- 6. Ancient Sedimentary Rocks
- 7. Regional Metamorphosed Rocks
- 8. Sea (Sedimentary Basin)

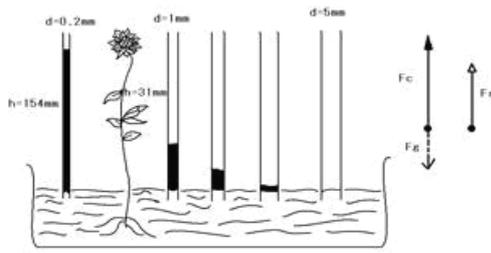
Fig. 7: Capillary Rise vs. Diameter of Pores (Massari)

Smaller the diameter, the higher the rise

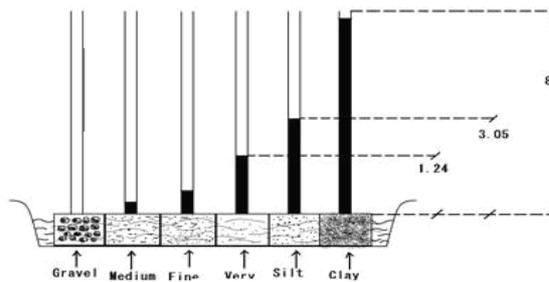
Fig. 8: Capillary Rise vs. Fineness of Particles (Massari)

gravel sand fine sand very fine sand silt clay  
The finer the particles, the higher the rise

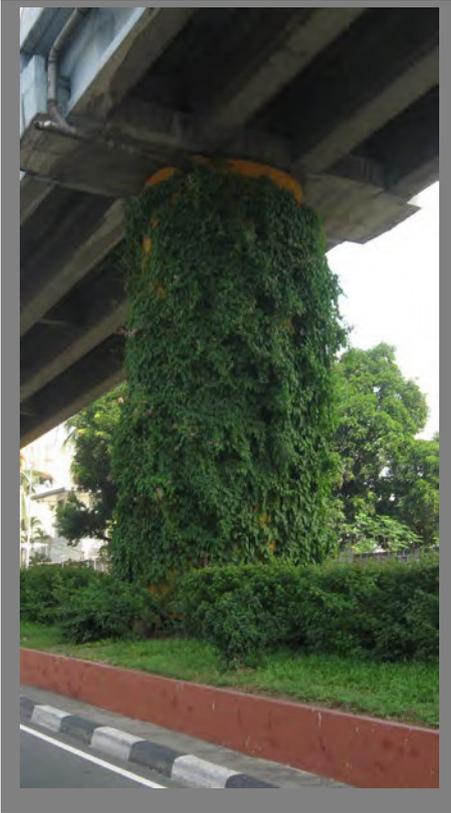
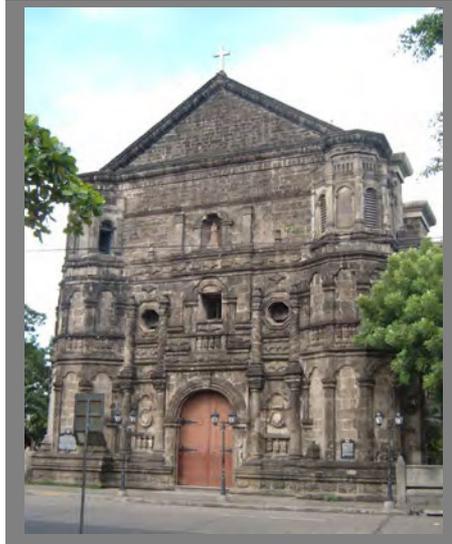
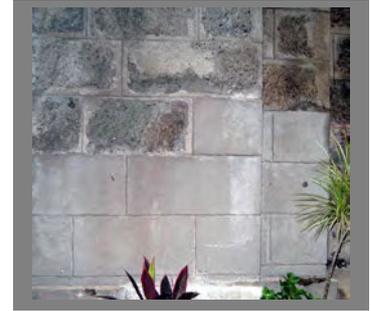
**Fig.10: Man and Stone Deterioration**

**INDUCED DETERIORATION:** Some plants can interfere with the foundation of the structure. The root system may reach lengths up to 8 meters; will penetrate the concrete, develop fissures, where water will start to seep in. Effects are detrimental to the structure and commuters. This is dangerous!

**CEMENT ON ADOBE:** Cement is too strong and compact for weak adobe. It leads to defacement. Damp from the ground, rain, leaking pipes, etc. penetrates the walls, dissolves the salts, which re-crystallize on the surface when water is changed to vapor as temperature increases. Air or vapor pressure from within the walls pushes the cement plaster but cannot "breathe". Stone is decayed underneath. Even incompatible paint prevents water in the wall, absorbed from the ground, from escaping towards the surface. *Use materials compatible with, never stronger than the original stone.*

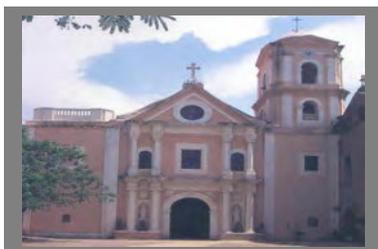
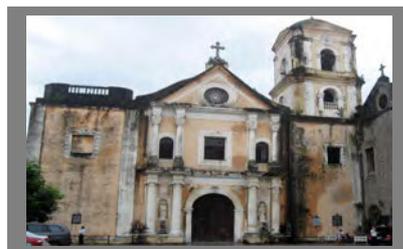
**FINDING THE SOURCE OF HUMIDITY:** Even with routine maintenance, regeneration and re-infestation of microorganisms, moss and algae will be unavoidable in a tropical country -as long as there will be moisture trapped within the walls. It is important to identify the source of the problem such as leaking pipes or defective downspouts before even attempting to clean or repaint.

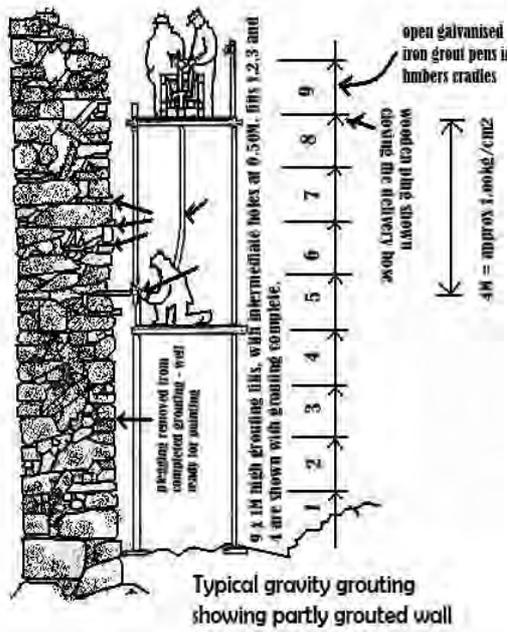
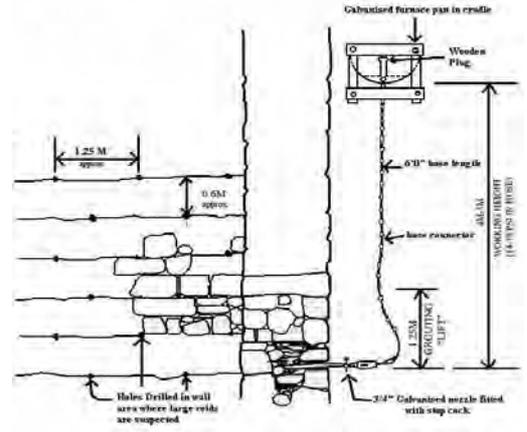
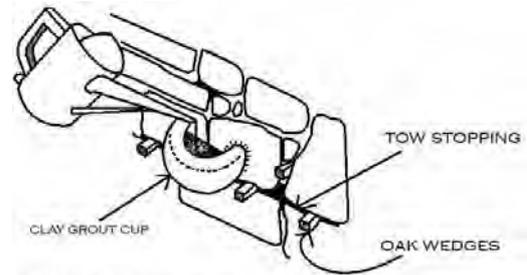
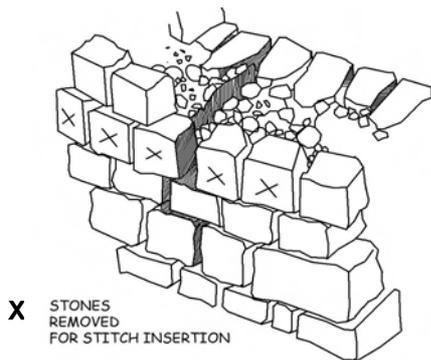
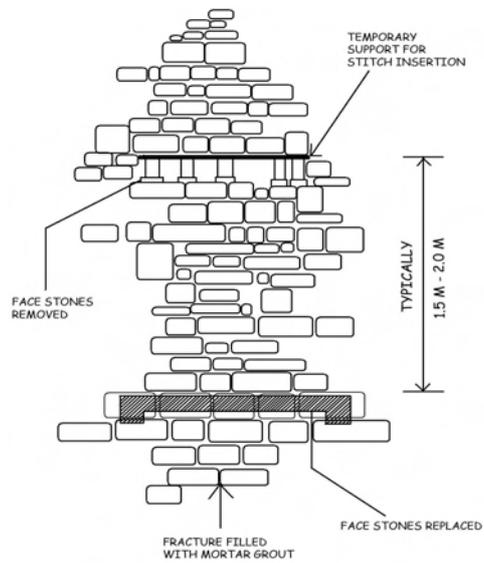
Fig. 12: Ashurst 's TECHNIQUES of GROUTING and STITCHING (John Ashurst)

**HAND GROUTING**

PRECAST OR CAST INSITU CONCRETE STITCH (REINFORCER)  
SYSTEM FOR TYPICAL DOUBLE

Physical and mechanical stabilization is the action taken to correct alterations affecting the physical properties of stone. It is to compensate for loss in physical strength due to the presence of fissures and cracks, weakening (pulverization) and loss of material, the effects of vegetation, vibrations and

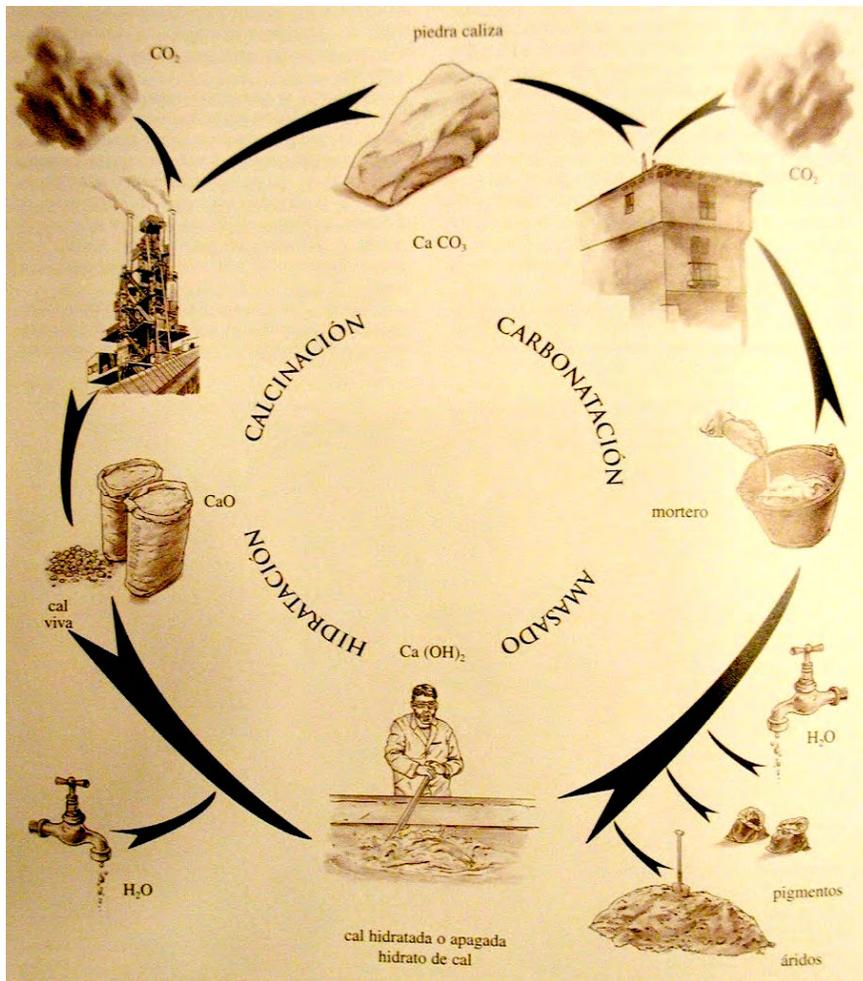
fig. 145 ciclo de la cal; fuente: Editorial de los oficios: Guia práctica de la cal y el estuco

The next figure illustrates the cycle of lime, where it begins in the form of stone and ends in the exact same chemical composition as the stone in the beginning.

After the cooking, the stones are moistened to produce a powder called “quicklime”, although the normal procedure for many building projects was to place the burnt lime in chambers or vats where it disintegrated into powder as it lay in water. In many Spanish documents and treatises on architecture and construction, a popular phrase appears “*entre mas podrida esta major,*” meaning the more time the lime spent under water, the better it’s qualities for construction became. The reason for keeping the lime in water was to keep it from hardening when exposed to the air. This is then the lime that is mixed with sand to make the mortar.

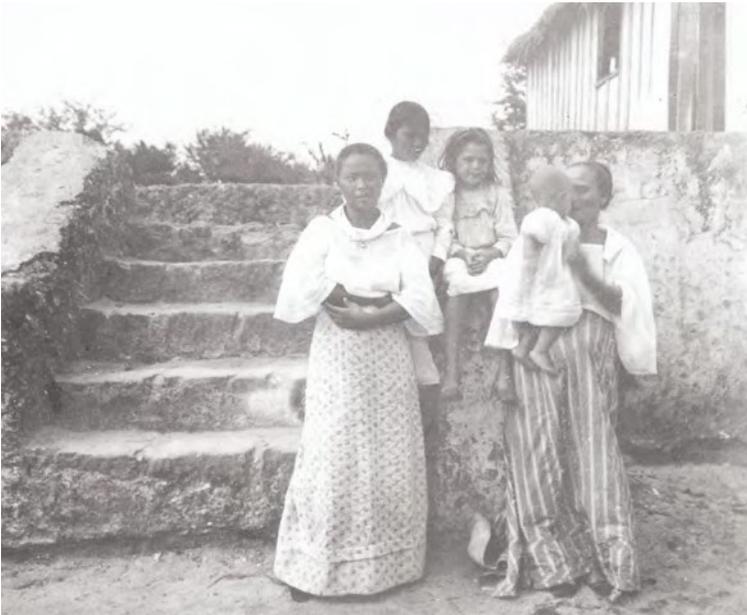
A massive stone stairway typical of *mampostería* architecture (Fritz Collection).

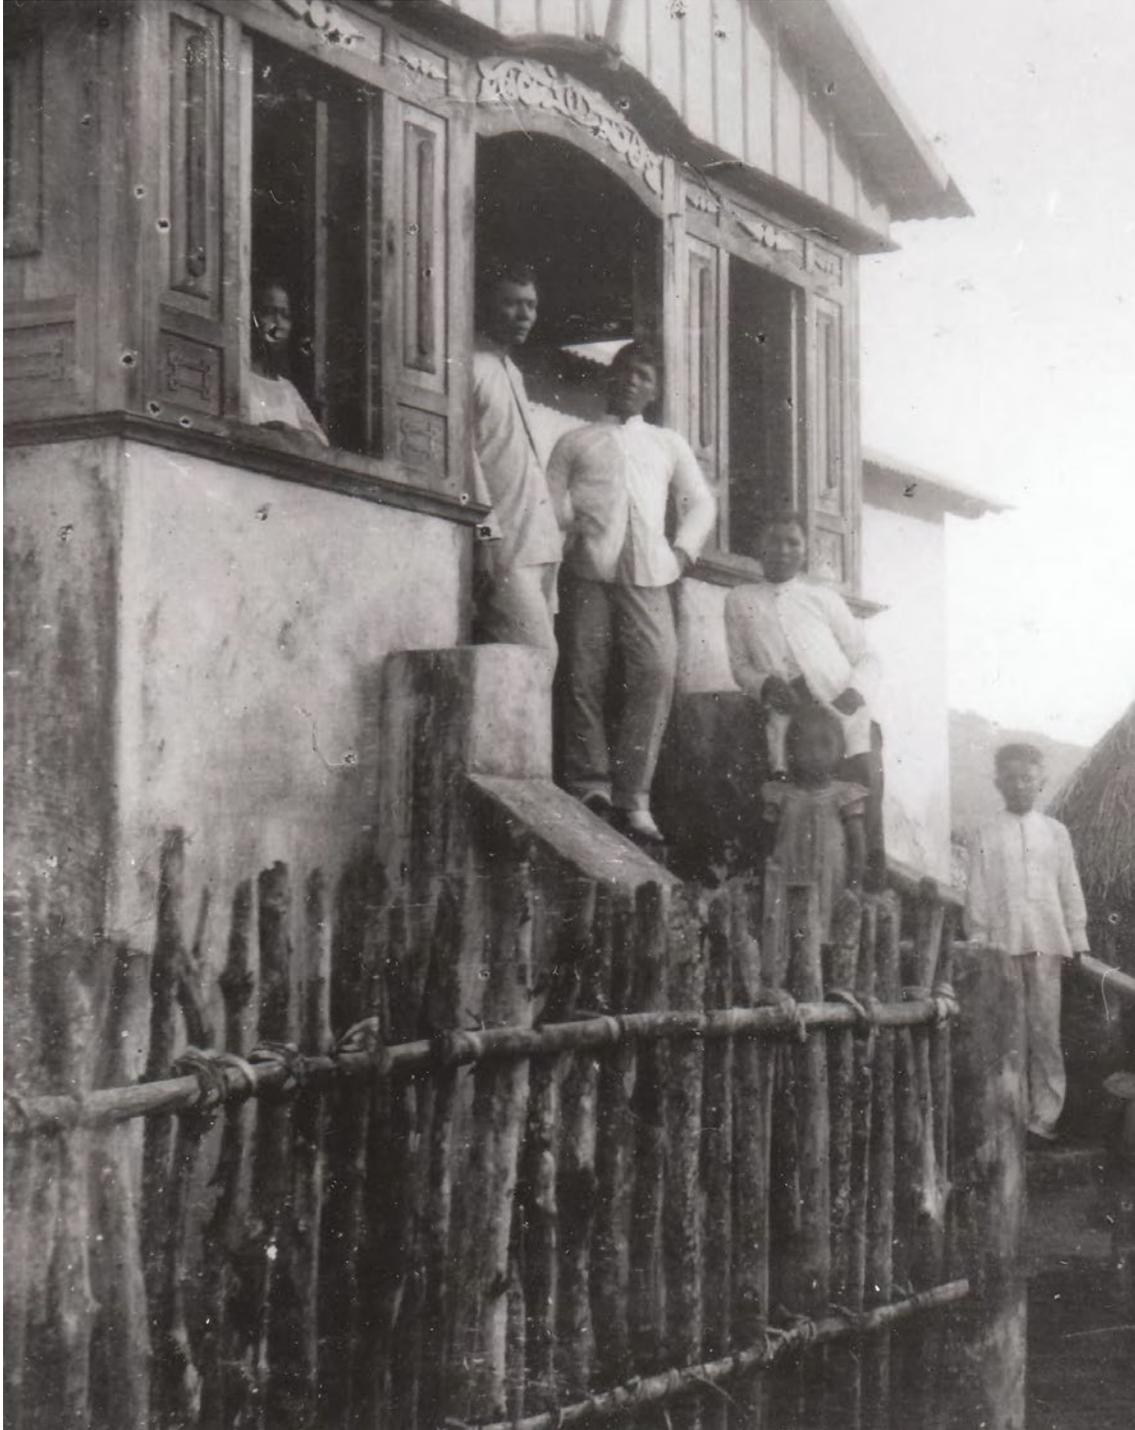
Details of the Ada residence, circa 1905 (Fritz Collection).
